## **Growth of Multiple-Site Fatigue Damage (MSD) in an Undamaged Fuselage Lap Joint Curved Panel**

### **Abstract**

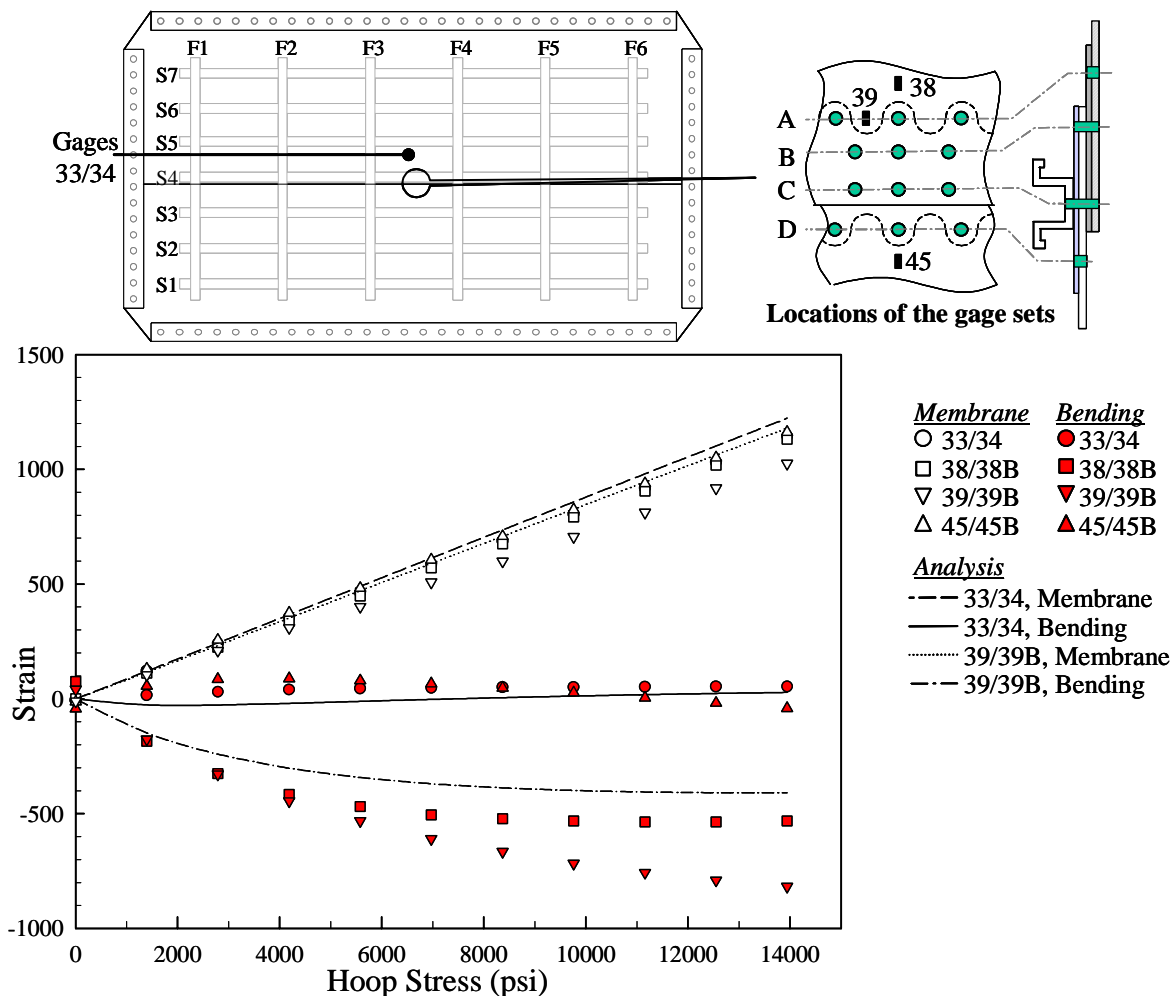
The eccentricity in the loading path due to the lap joint geometry produces severe out-of-plane bending deformation in the lap joint area. Several sets of back-to-back strain gages were installed at various locations on the panel to verify this local bending effect. Figure 2 depicts schematically the locations of four such back-to-back gage sets: (1) set 33/34 at a skin mid-bay region, (2) set 38/38B at a distance of 0.5" above rivet row A, (3) set 39/39B along rivet row A midway between two rivets, and (4) set 45/45B 0.5" below rivet row D. The membrane strain component (the average of the strain measurements at the inner and outer surfaces) and bending strain component (half of the difference between the two measurements) for each gage set are shown in Figure 2. It can be seen that the membrane strain component is nearly the same at the four locations. The bending strain component, on the other hand, differs significantly, with the highest value being recorded at gage set 39/39B along rivet row A. As a result of this severe local bending, the skin inner surface along the outer rivet row of the lap joint experiences high tensile stresses making this rivet row a critical area for damage initiation. Local bending also explains why cracks generally initiate at the skin inner-faying surface and propagate outward.

Figure 2 also shows the predictions of the geometrically nonlinear finite element analyses. It can be seen that the predictions of membrane strain components compare very well with the strain gage measurements. Predictions of the bending strain component in the lap joint region, on the other hand, are not as good and are in general lower than the strain gage measurements. In the finite element model,

rivets in the lap joint region are represented by beam elements, and a perfect bonding between rivets and skins assumed. These assumptions make the finite element model much stiffer than the actual structure, resulting in lower strain values in the lap joint region.

**Figure 2.** Membrane and bending strain components at four back-to-back strain gage locations on the skin.

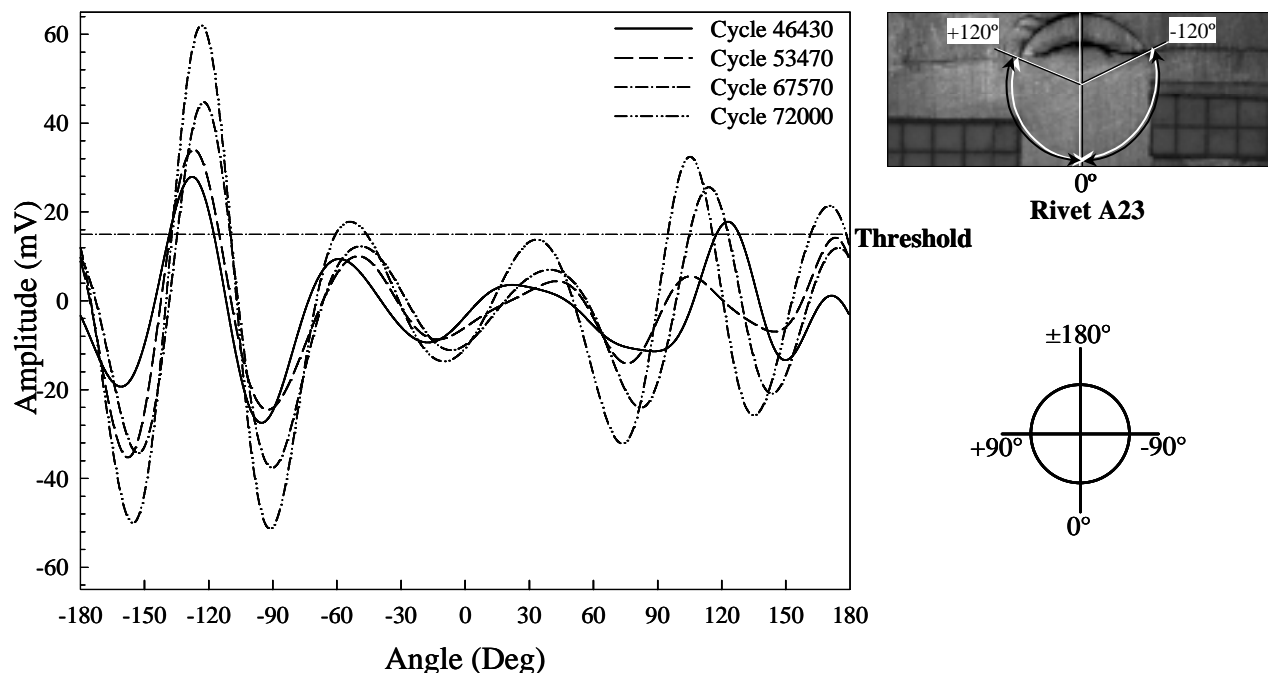
Figure 3 shows the output of the Self-Nulling Rotating Eddy-Current Probe system obtained from the rivet hole of rivet A23. Output amplitudes above the threshold (15 mV) indicate presence of damage. Results in Figure 3 show that high eddy-current signals were detected at the +120° and -120° locations, indicating possible existence of hidden cracks. Figure 4 schematically depicts the evolution of the distribution of rivets in the lap joint area showing high eddy-current signal during the test. After 26,360 fatigue cycles, high eddy-current signal was detected at 3% of the rivets in row A and four rivets in row B. After 53,470 cycles, 11% of row-A rivets exhibited high signals while the number of high-signal rivets in row B remained unchanged. After 75,114 fatigue cycles, 20% of row-A rivets and 4 out of the 6 shear clip rivets near row A showed high eddy-current signal. At 107,222 cycles, shortly before the end of the fatigue test, 48% of row-A rivets and all but one shear clip rivets near row A had high eddy-current

**Figure 3.** Eddy-current inspection results of rivet A23 showing signal amplitude vs angular location.

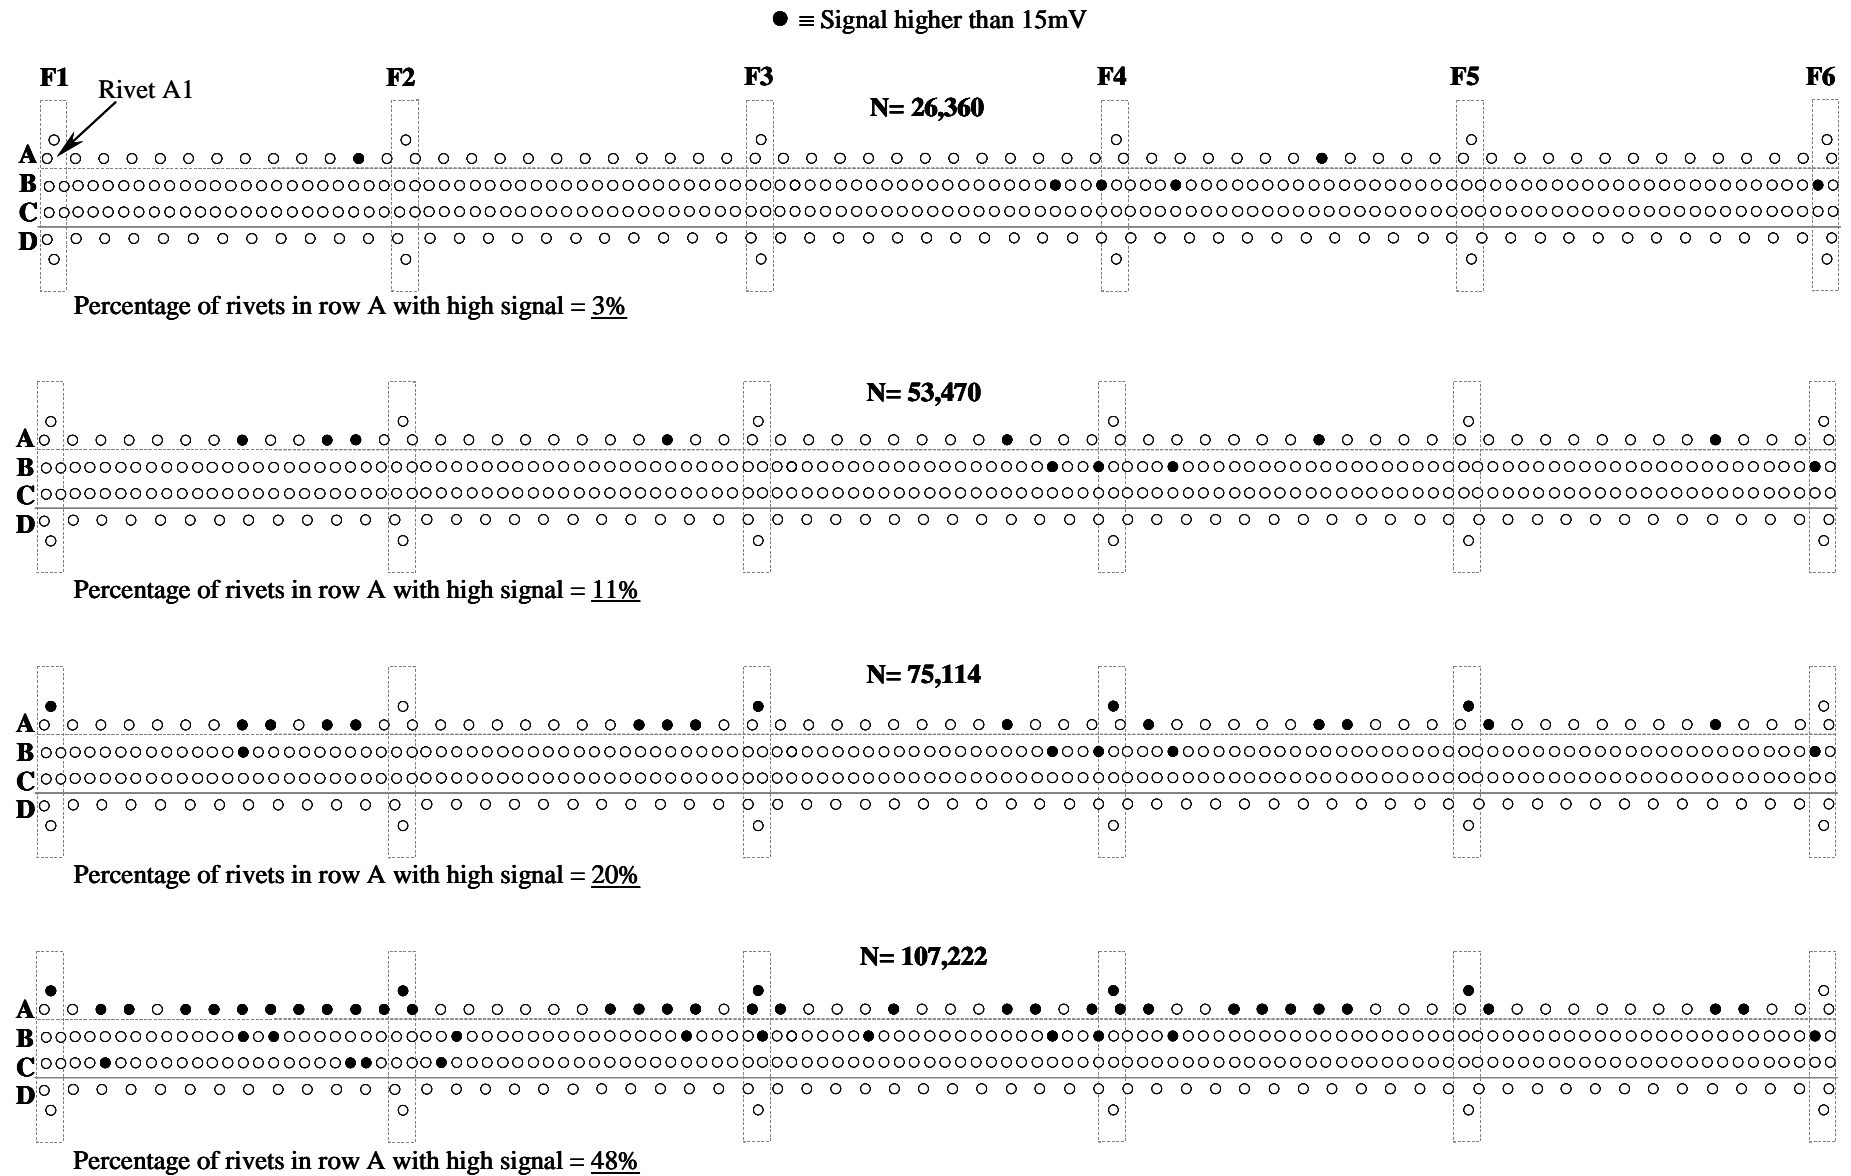
MSD cracks in the panel were detected only at rivet holes in row A and at the nearby shear clip rivet holes. Although indications of subsurface damage were seen in rows B and C, no visual cracks were detected in those rivet rows. Some row-B rivets have shown high signal since the baseline inspection, but no visible cracks. Rivet row D was not accessible for inspection with the rotating probe system during the test. Through a special setup, rivets in row D were inspected at the end of the fatigue test and high signals were found at three rivets. The fact that most damage indications were found in the lap joint outer rivet row can be attributed to the significant out-of-plane deformation of the skin along that rivet row as was indicated by the results of test phase I.

**Figure 4.** Locations of rivets with high eddy-current signal at different stages of the fatigue test.

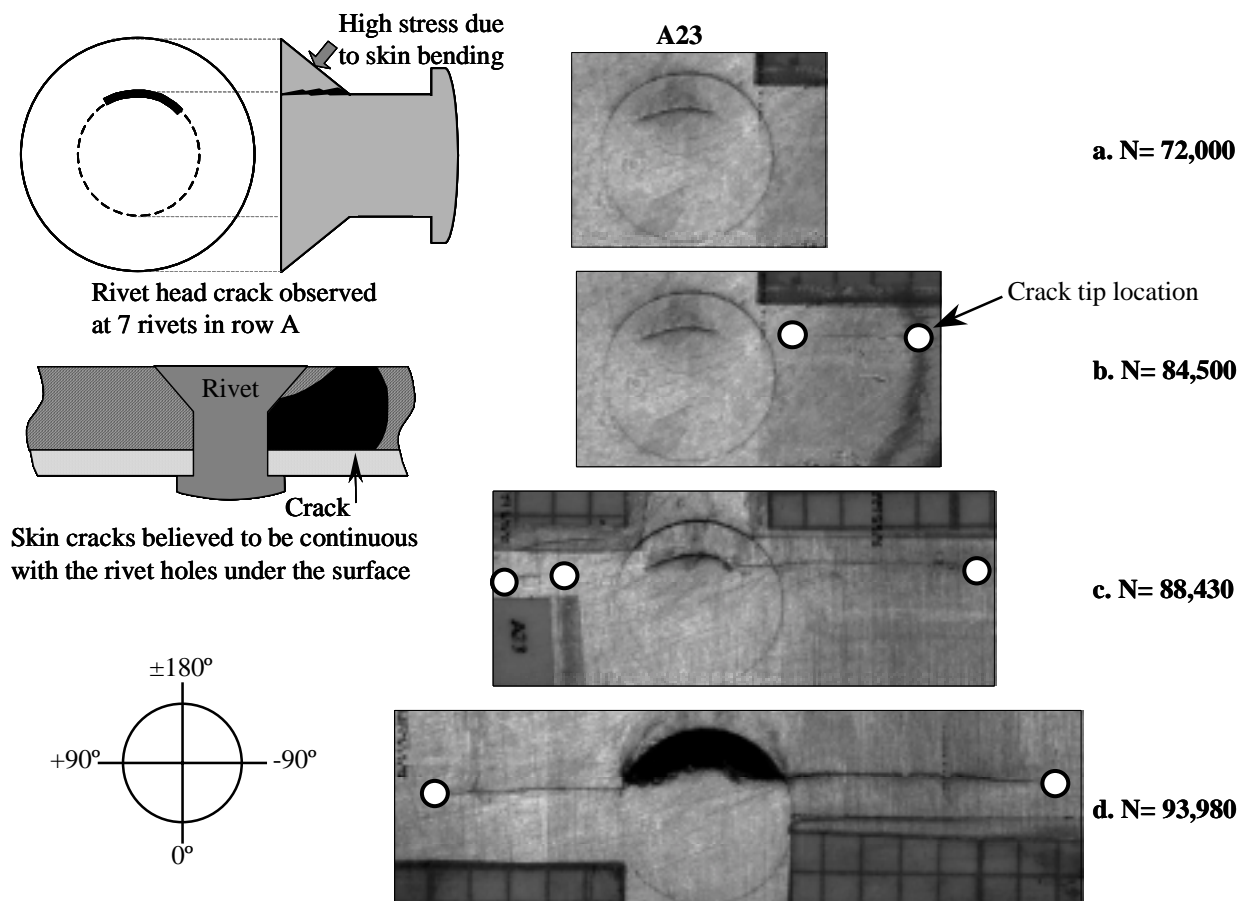
Visible MSD cracks were detected in two areas in the panel: the lap joint outer rivet row and the nearby outer skin shear clip rivet locations. MSD cracks initially formed both on the rivet heads and in the skin. After 51,500 full-load cycles, a curved crack in the rivet head was detected in rivet A23 located between frames 2 and 3 (Figure 5(a)). Similar rivet head cracks were detected at seven other rivets in row A. Water leakage from the rivet head cracks indicated that the cracks were through the thickness. Apparently, the high out-of-plane bending along rivet row A (see test phase I) caused the skin to push up against the rivet heads to form the cracks (Figure 5). Since the panel was constructed per the original equipment manufacturer specifications, the rivets were not designed to sustain loads as high as was applied in the fatigue test. Future fractographic analysis may define the mechanism of formation of these rivet head cracks.

**Figure 5.** Damage evolution at rivet A23 of the lap joint outer rivet row. The white circles indicate crack tip locations.

Cracks in the skin of the lap joint were detected near rivet A23 in the outer rivet row (Figure 5). The first crack, designated crack A23R, was detected at about  $-120^\circ$  orientation after 80,550 fatigue cycles. This crack initiated at a distance from the edge of the rivet hole and grew to linkup to the rivet hole (Figure 5(b)). Later, crack A23L was detected on the other side (left side) of rivet A23 at about

+120° orientation (Figure 5(c)). This crack also initiated at a distance from the rivet hole and linked up to the rivet hole.

The rivet-head crack of rivet A23 grew across the rivet head and linked with the skin cracks on both sides of the rivet. The upper portion of the rivet head was completely separated (Figure 5(d)). Two skin cracks, A22L and A22R, were later detected at the neighboring rivet A22. The two cracks at rivet A22 also initiated at away from the rivet hole. It appears that the cracks at rivets A22 and A23 had completely linked up to the rivet hole below the surface by the time they were detected on the surface (Figure 5). It is possible that residual stresses from the riveting process may have caused the cracks to propagate to the surface away from the rivet holes. Future analysis and fractographic examination will provide information on this phenomenon.

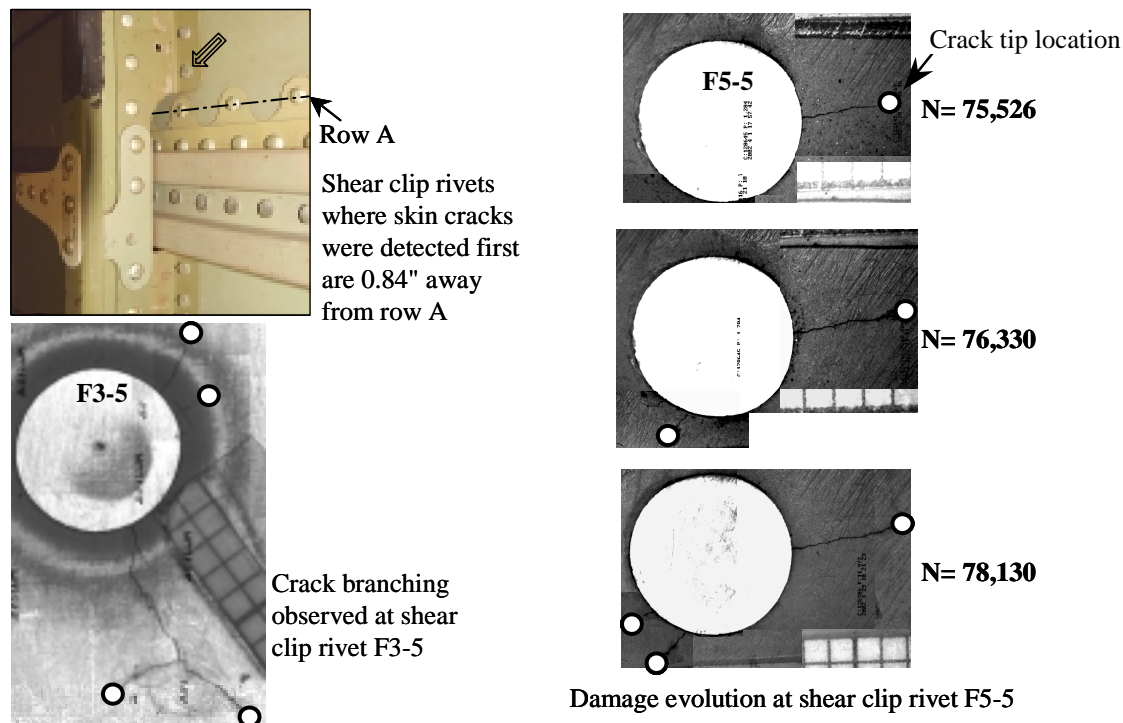
Visible MSD cracks were also detected emanating from the shear clip rivet holes near the outer rivet row of the lap joint. Those rivet holes are 0.84" away from rivet row A. Figure 6 depicts RCCM images of the skin cracks at rivet F5-5 at frame 5. The first crack at that rivet was detected at an orientation of -90° after 75,510 full-load fatigue cycles. A second crack was detected 50 fatigue cycles later at +15° orientation. At 76,630 cycles, a third crack was detected at rivet F5-5 at +45° location. More cracks were detected at the same time at rivets F4-5 at frame 4, and later at rivet F3-5 at frame 3. Seven cracks were found at rivet F4-5, three were found at F3-5, and crack branching was observed at rivet F3-5 (Figure 6). The damage pattern at these three shear clip rivet holes was similar, with one faster-growing dominant crack and multiple smaller cracks. At 105,700 fatigue cycles, cracks were detected at rivet F2-5 at frame F2.

**Figure 6.** Damage growth at the shear clip rivets near the lap joint outer rivet row.

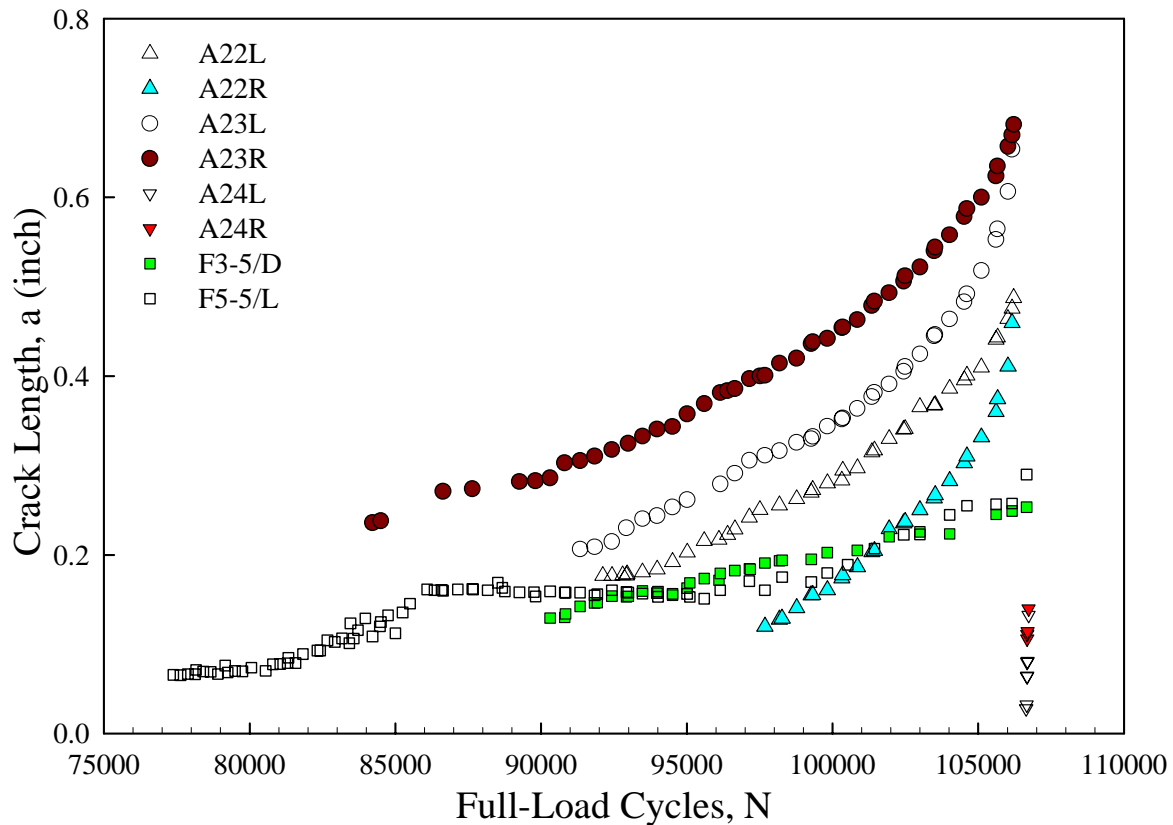
Figure 7 shows the MSD fatigue crack growth behavior in the test panel. The first four cracks detected in the lap joint (cracks A22L, A22R, A23L, and A23R) have similar growth behavior. The two

shear clip cracks, designated F3-5D and F5-5L, were detected earlier but grew slower compared to the cracks in the outer rivet row of the lap joint. This is a result of the higher stiffness at the shear clip

attachment to the skin. Across a skin bay, the frame locations have the lowest hoop strain.

**Figure 7.** Crack size vs load cycles for cracks detected in the panel.

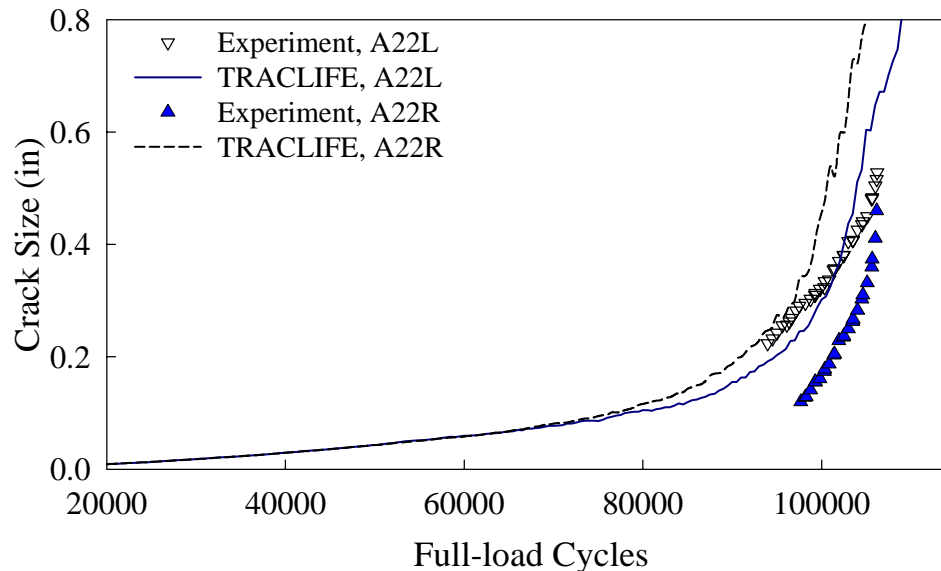
TRACLIFE was used to conduct probabilistic crack growth analyses of individual MSD cracks in the test panel prior to linkup. Figure 8 show TRACLIFE results for cracks A22L and A22R. TRACLIFE prediction was in good agreement with experimental results of crack A22L, but was on the conservative side for crack A22R. This crack was growing toward crack A23L and ultimately linked up with it. Similar TRACLIFE results were obtained for the two cracks at rivet A23.

**Figure 8.** TRACLIFE analysis results for cracks at rivet A22.

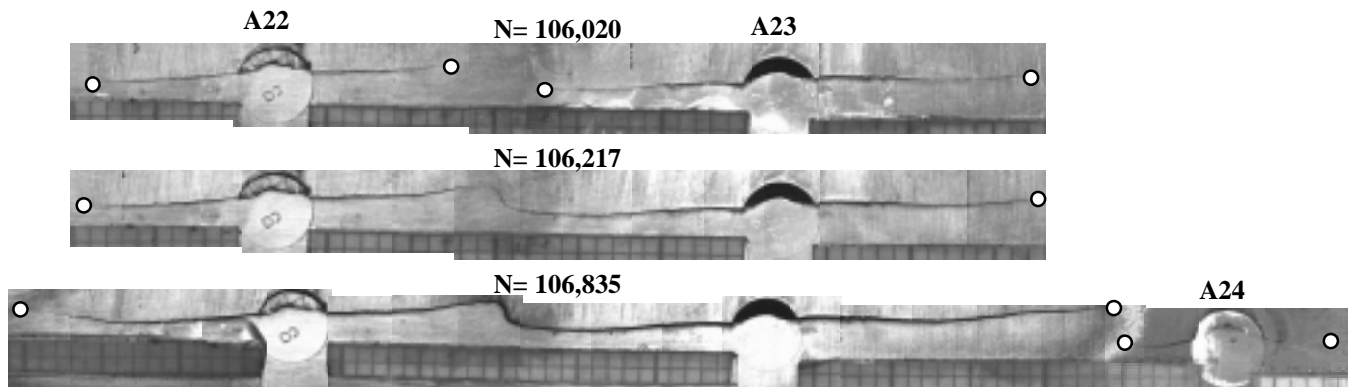
Figure 9 shows the first linkup of MSD cracks. It occurred after 106,217 full-load fatigue cycles in the outer rivet row of the lap joint between rivets A22 and A23. After the linkup, the lead crack had a total length of 2.87". Figure 10 shows the different stages of growth of the lead crack formed by the first MSD linkup. Shortly after the first linkup, cracks were detected emanating from rivet hole A24. Cracks A24L and A24R were detected at cycles 106,644 and 106,680, respectively. Unlike the cracks at A22 and A23, the two cracks at A24 were completely linked to the rivet hole when first detected. Because of the high stress field created ahead of the lead crack, cracks A24L and A24R grew faster compared to the lap joint cracks detected earlier (Figure 7).

**Figure 9.** First MSD linkup occurred between rivets A22 and A23 in the lap joint outer rivet row after 106,217 full-load cycles.

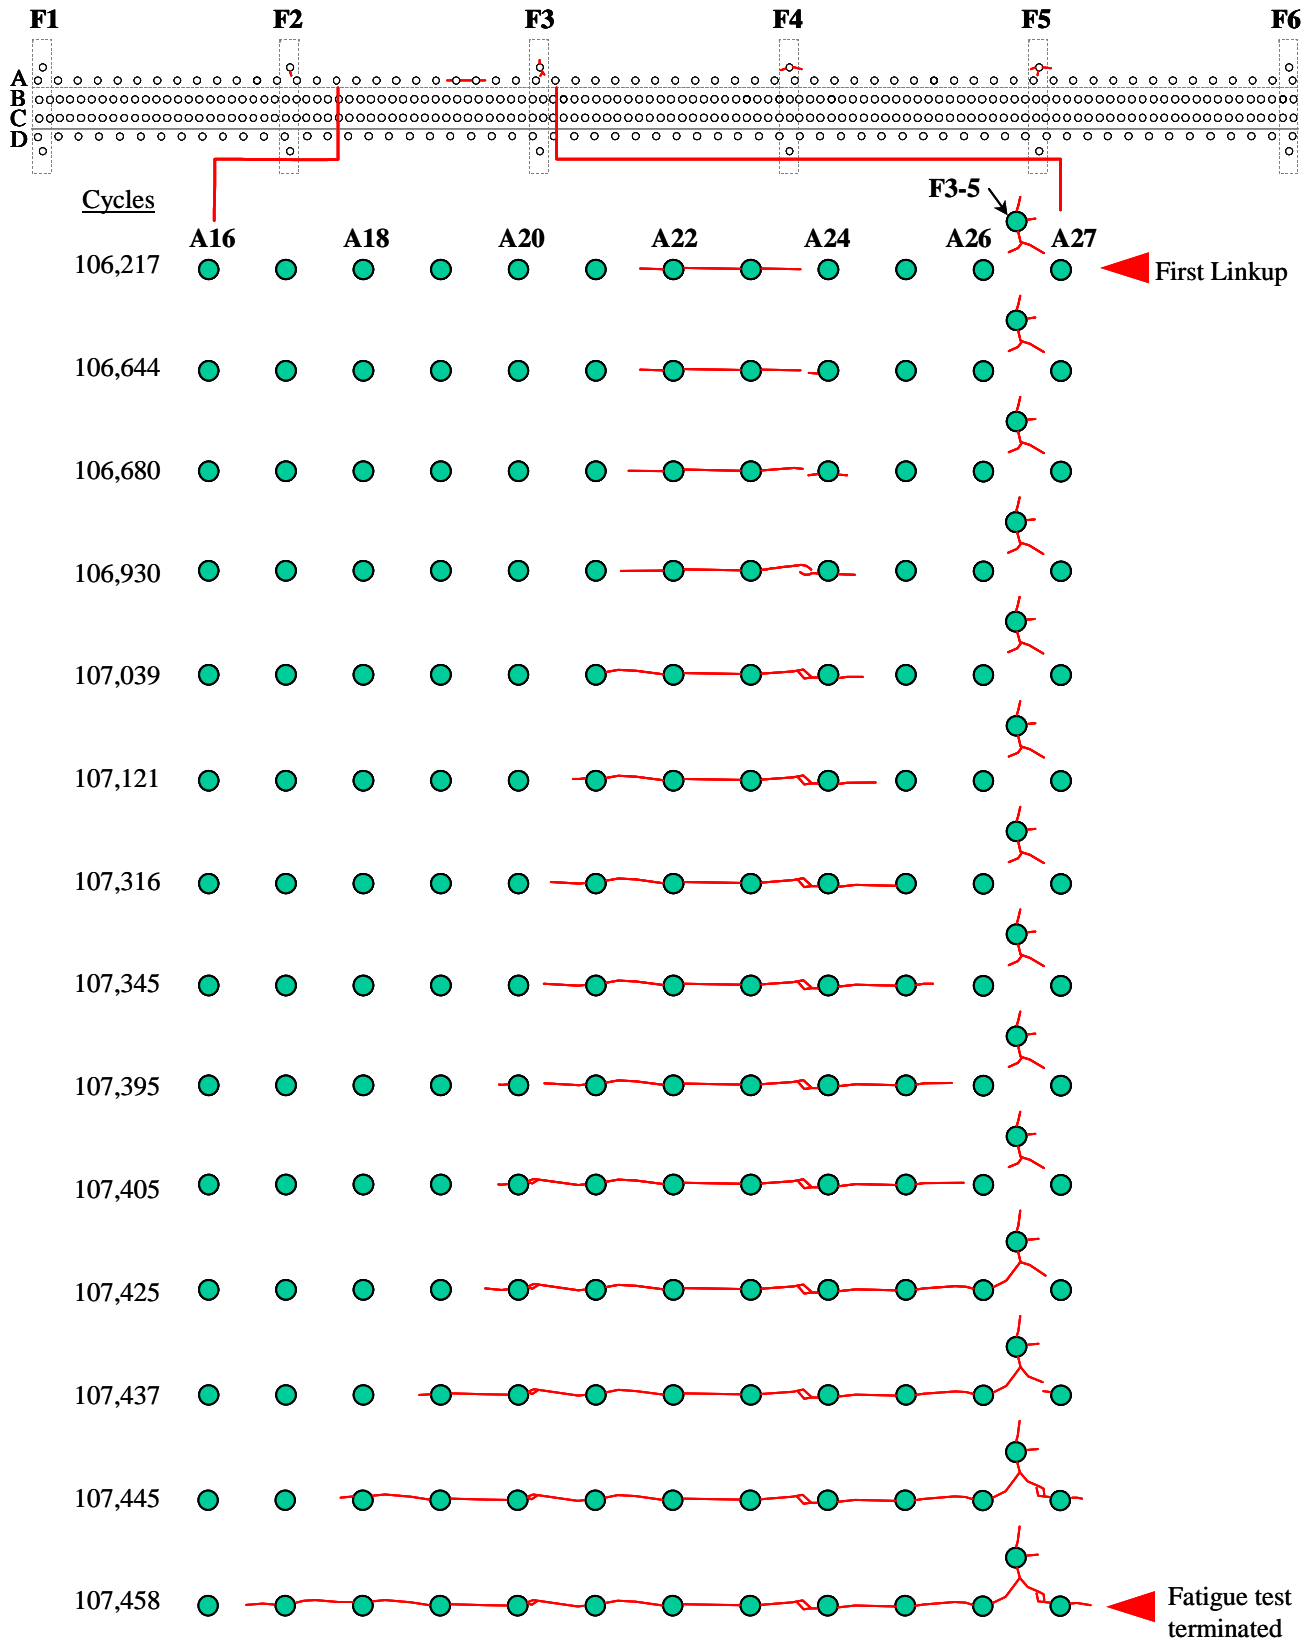
The second linkup happened 713 cycles after the first one when the lead crack and crack A24L bypassed each other. The two cracks slowed down and curved toward each other to form a football shape. After another 109 cycles (at 108,039 fatigue cycles), the lead crack grew into rivet hole A21 to the left. No crack was detected at rivet hole A21 before the linkup.

The lead crack then grew rapidly at both ends. At 107,425 fatigue cycles, the lead crack extended to the right through rivet hole A26 and linked up to one of the existing cracks at shear clip rivet F3-5. Shortly after that, a short crack was detected on the left side of rivet hole A27. By 107,458 cycles, the lead crack had grown to a total length of 16.04", spanning slightly beyond rivet A27 to the right to about midway between rivets A16 and A17 to the left (Figure 10). At that point, the crack grew appreciably with every fatigue cycle and the fatigue test was terminated.

**Figure 10.** A schematic illustrating lead crack growth during the fatigue test

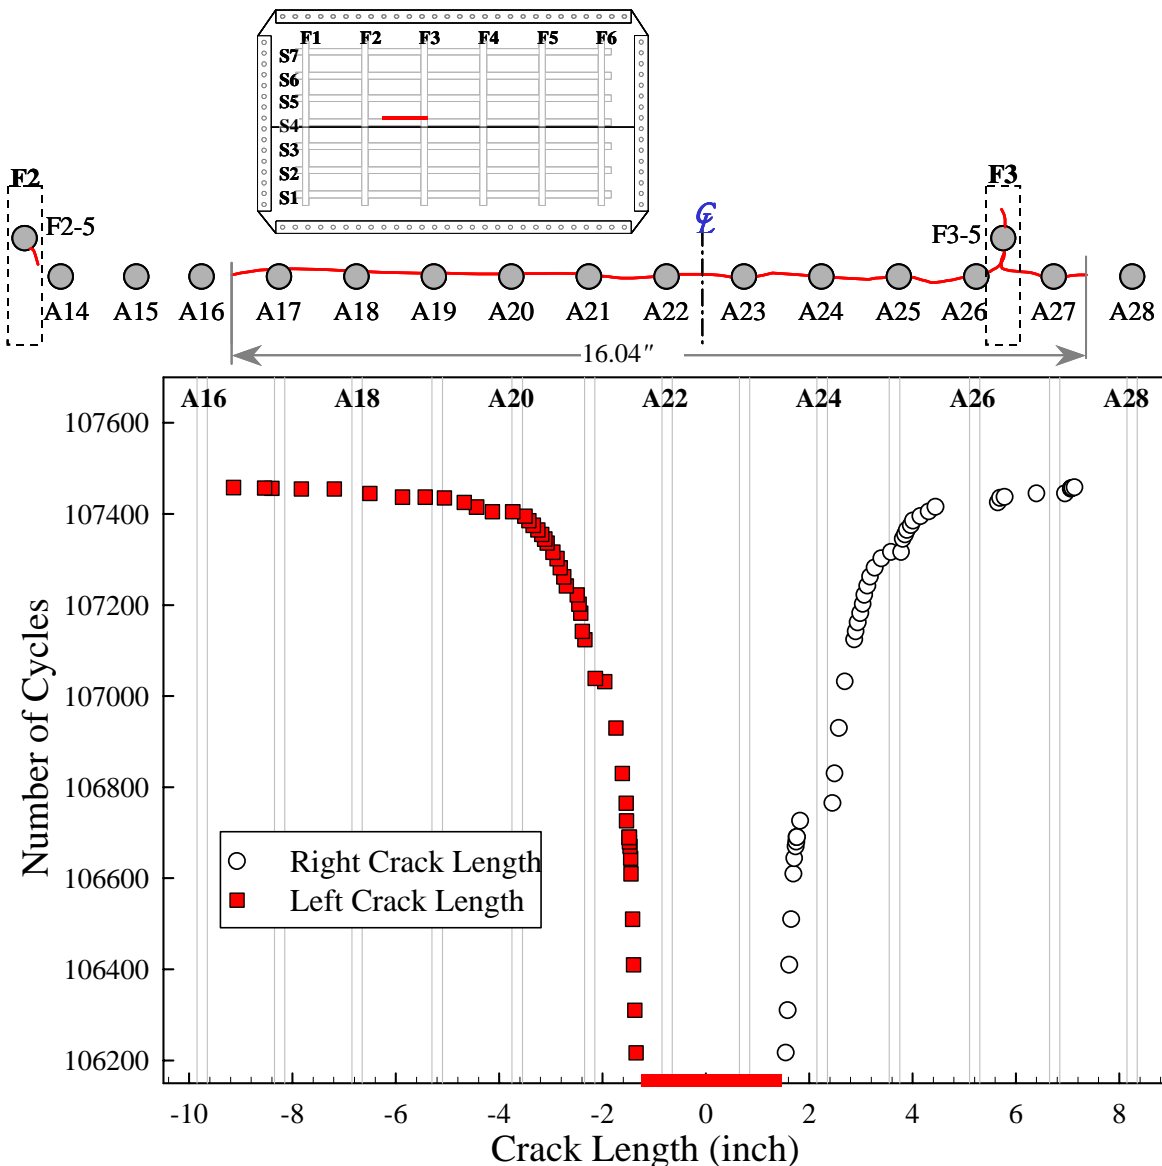
Figure 11 shows the growth of the lead crack as a function of fatigue cycles up to the end of fatigue test at 107,458 cycles. The left and right crack lengths are measured from the centerline midway between rivets A22 and A23 where the first linkup occurred. It can be seen that the lead crack initially grew at approximately the same rate in both directions, but the growth rate of the right crack tip decreased significantly as it approaches frame F3. At the end of fatigue test the lead crack grew to a length of 16.04", extending along the outer rivet row of the lap joint mainly in bay two but crossing over frame F3 slightly into bay three.

**Figure 11.** Growth of the right and left crack tips of the lead crack during the fatigue test.

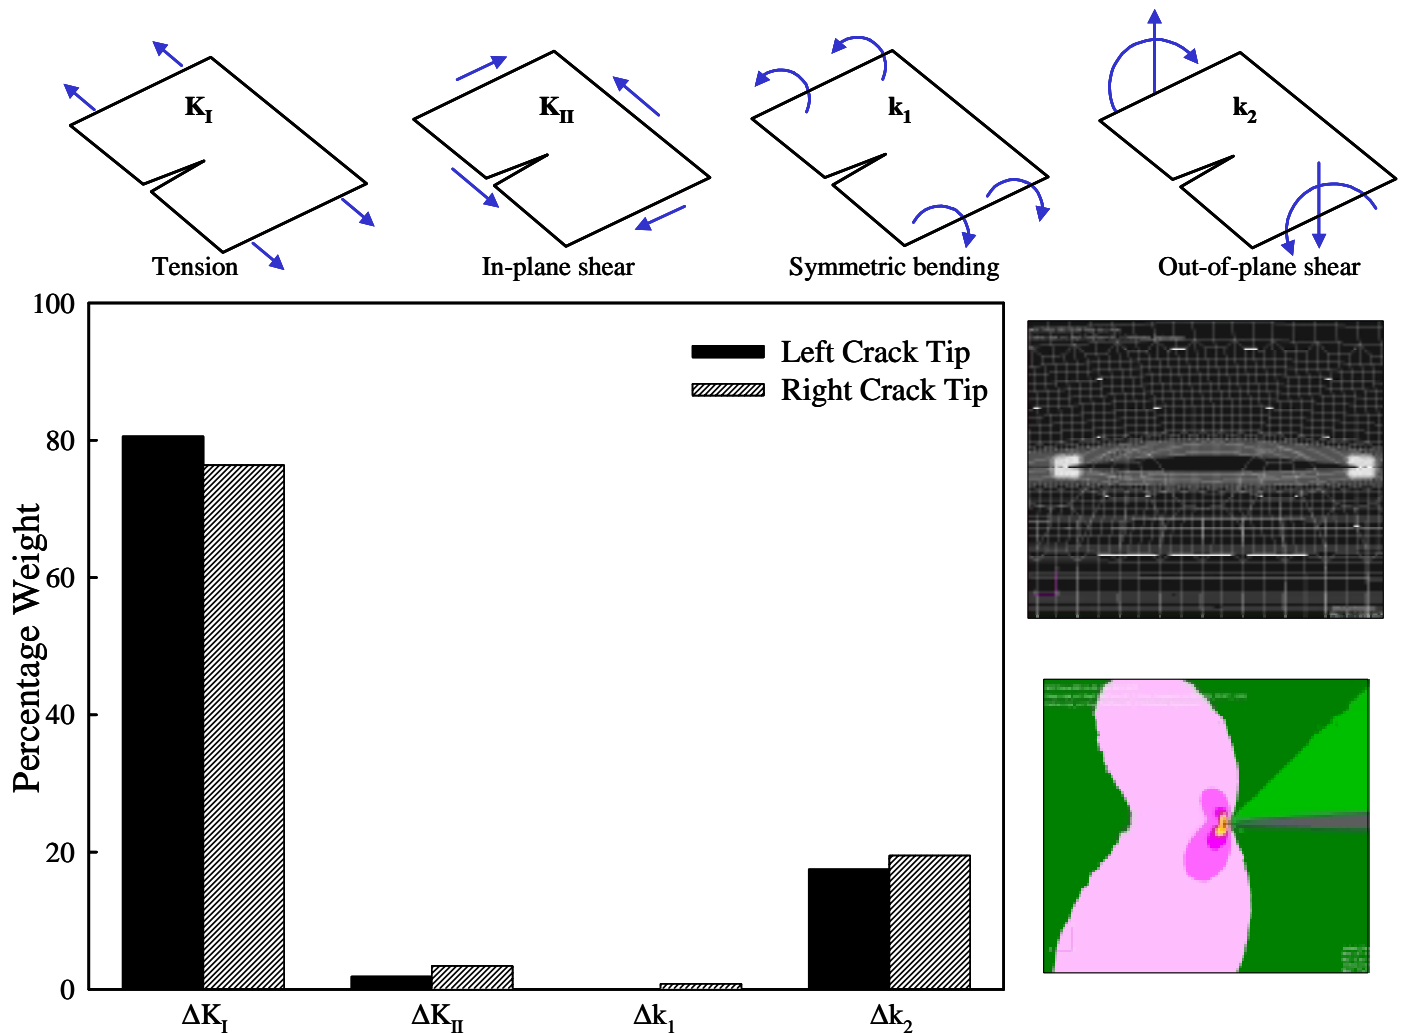
In the finite element analysis of the lead crack formed by the first MSD linkup, the MCCI method was used to calculate the stress-intensity factors at the left and right crack tips. Figure 12 shows the relative weight of the stress-intensity factors in this mixed-mode crack growth scenario.  $\Delta K_I$  (in-plane tension mode) amounts to about 80% of the total  $\Delta K$  at each crack tip. Next in significance was  $\Delta k_2$  (out-of-plane shear mode) representing about 19% of the total  $\Delta K$ . The two remaining components,  $\Delta K_{II}$  (in-plane shear mode) and  $\Delta k_1$  (symmetric bending mode), were negligible. Noticeable skin bulging at the crack confirmed the relatively high  $\Delta k_2$ . The value of  $\Delta K_I$  at the left crack tip was about 5% higher than that of the right crack tip. This difference in the dominant stress-intensity factor is attributed to the difference in the stress field. The difference in stress-intensity factors caused the asymmetric growth of the lead crack (Figure 11).

**Figure 12.** Relative weight of the stress-intensity factors at the crack tips of the lead crack.

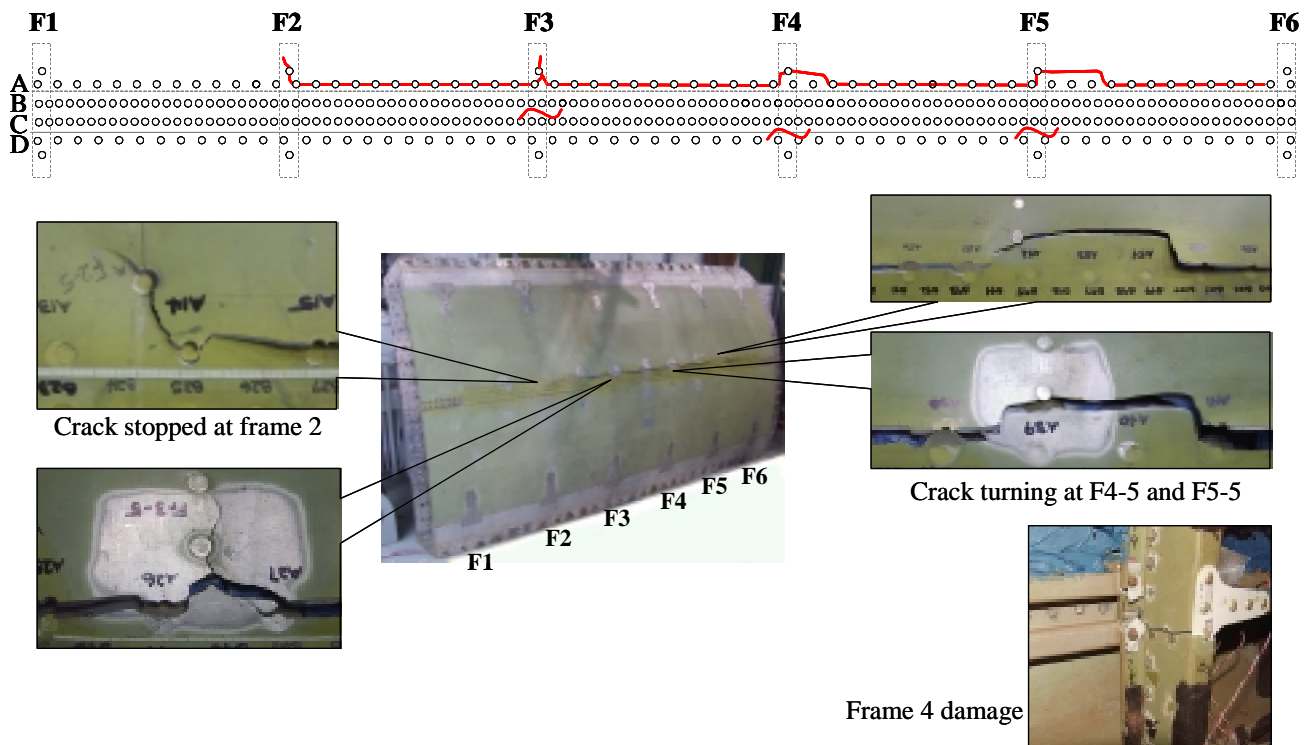
During the residual strength test, loads were applied quasi-statically with a pressure increment of 2 psi up to 14 psi and an increment of 1 psi afterwards. Further crack extension was observed at 16-psi pressure. Catastrophic failure occurred at pressure 17.8 psi. The lead crack abruptly extended to a five-bay, 75" crack. Figure 13 shows the final state of damage after the residual strength test. The left crack tip of the lead crack extended to frame F2, linked up with the crack at shear clip rivet F2-5, and then stopped about 0.5" past rivet F2-5. The right crack tip extended much further, stopped between rivets A62 and A63 just before frame F6. As the crack extended through frames F4 and F5, it turned upwards and linked up with the cracks emanating from shear clip rivets F4-5 and F5-5 and skipped two or three rivet holes in row A before turning downwards to continue extending along the rivet row. A posttest inspection on the inner surface of the panel showed that frames F3, F4, and F5 all fractured under the lap joint. The damage at frame F4 is shown in Figure 13.

**Figure 13.** Final state of damage at the end of the residual strength test.
